C.C.H.O.A.
505 Grand Caribe Cswy.
Coronado, CA 92118

HOMEOWNERS ASSOCIATION

Dear Montego Villagers:

The CCHOA Board wants to emphasize that it will be the Montego owners who decide whether the parking structure is demolished and NOT the Board of Directors. The purpose of this letter is to clear the air on issues raised by a concerned owner.

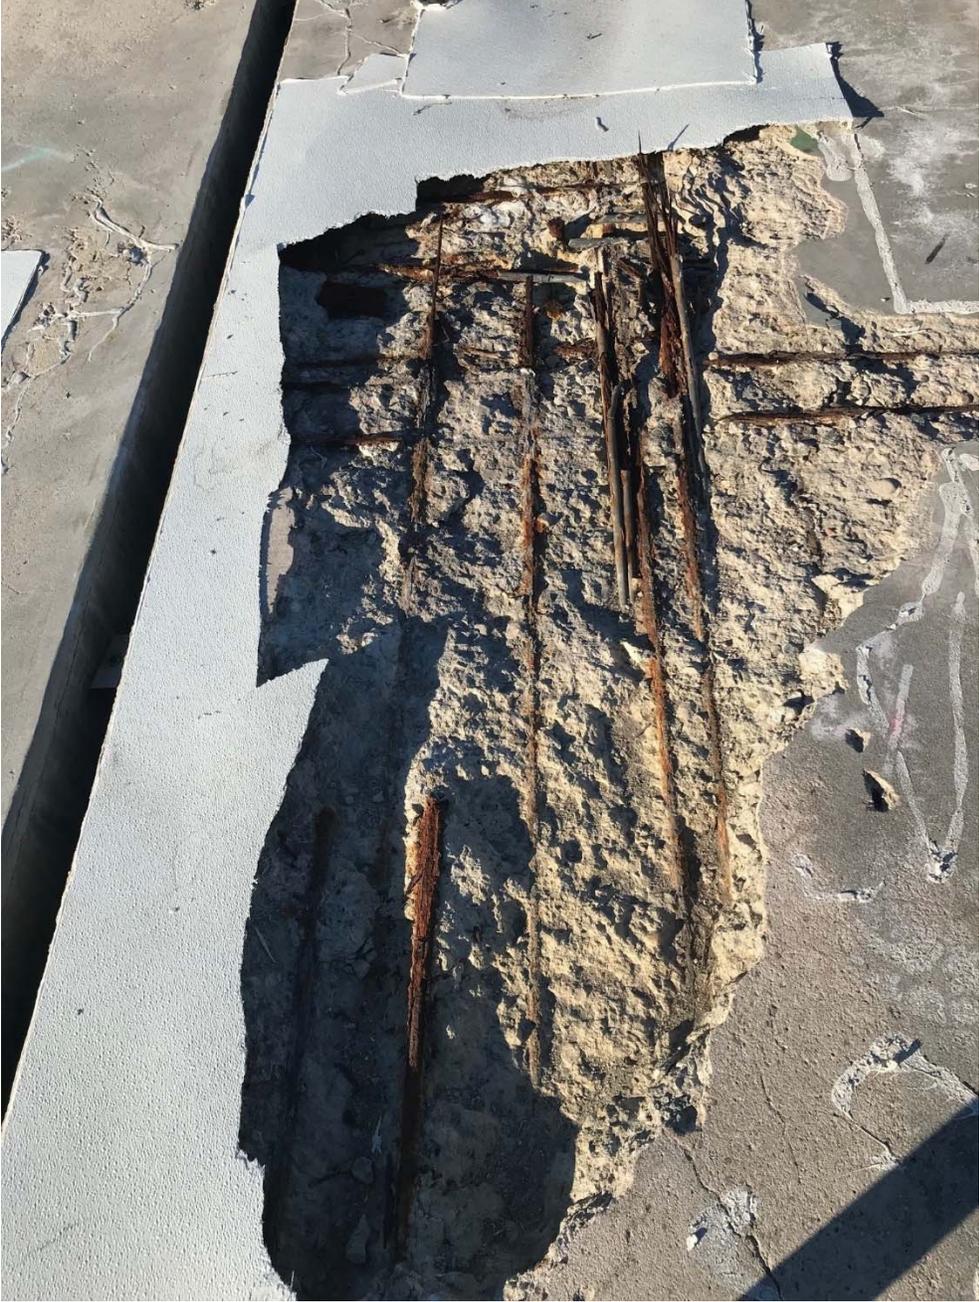
2022 0124 Photo 001 Disintegrated Cables Center Line

Photo 001: Damaged and Disintegrated Rebar and Cables Centerline of Slab

Damage to the 41-year old structure was evident during the Reserve Study conducted by engineers and HOA Staff in late 2019/early 2020. The extent of the damage was revealed when the tennis court coating was removed in October 2020. Post-tensioned cables and rebar (buried in concrete) were found to be disintegrated or severely corroded and a network of cracks above each support column was revealed. A specialized contractor attempted to repair the cables and was pulled off the job as it was deemed unsafe and unrepairable.

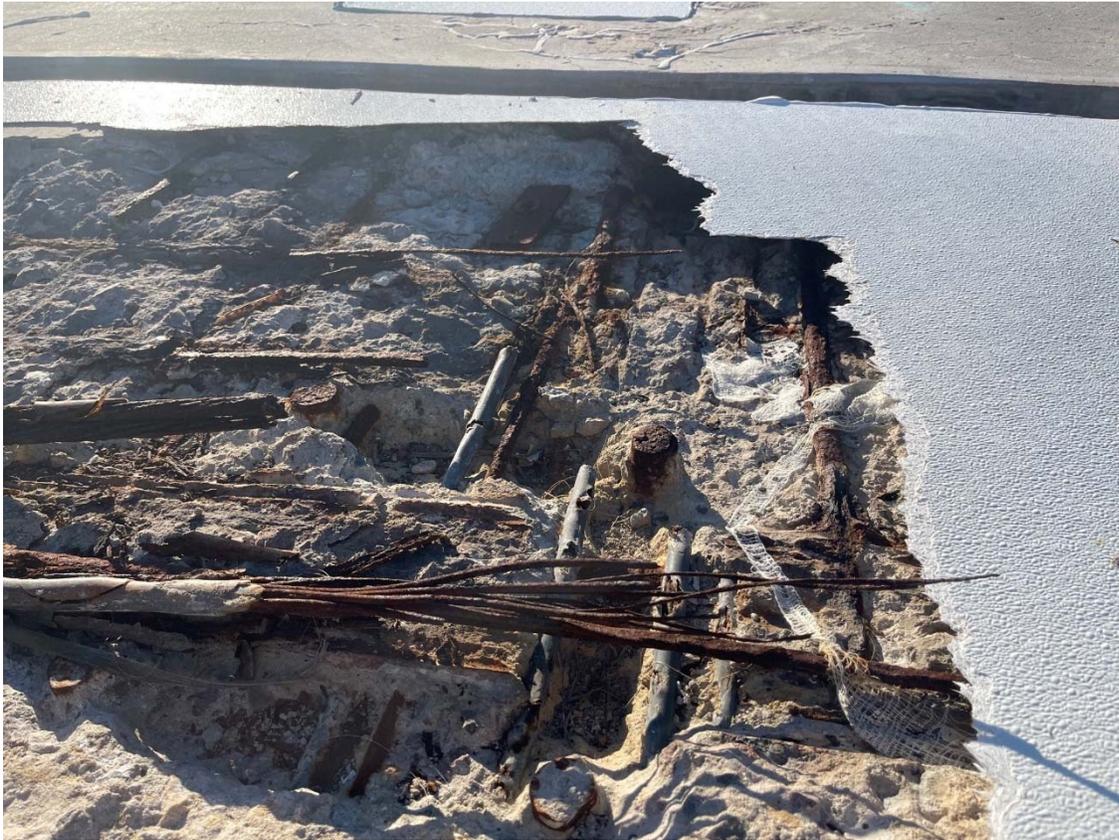
2022 0124 Photo 001A Closeup Disintegrated Cables Center Line

Photo 001A: Closeup of Damaged and Disintegrated Rebar and Cables Centerline of Slab

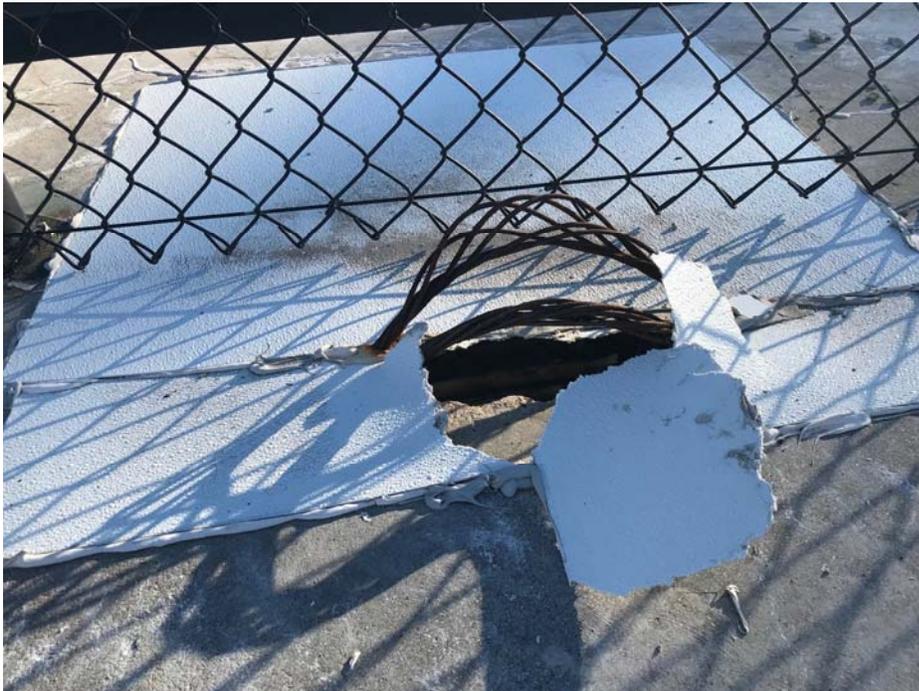
2022 0124 Photo 002 Cables Popping Up

Photo 002: Post-Tensioned Cables Popping Out of Slab (2nd cable popped out sometime in December/early January and broke the temporary cover)

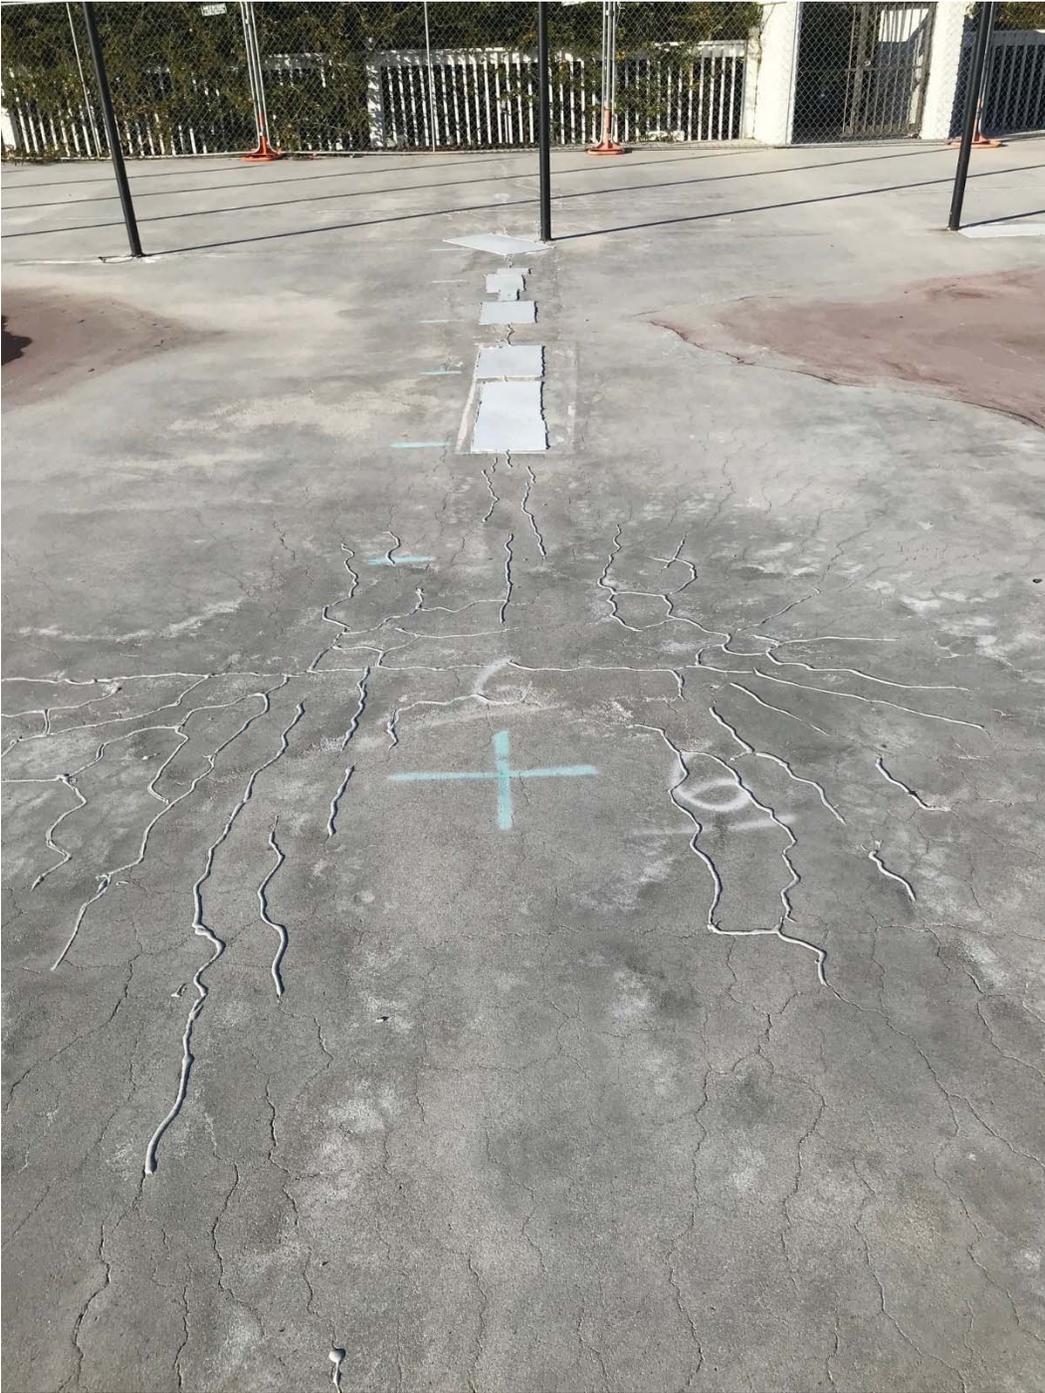
2022 0124 Photo 003 Support Column Radial Cracking

Photo 003: Radial Cracking Pattern over Support Columns

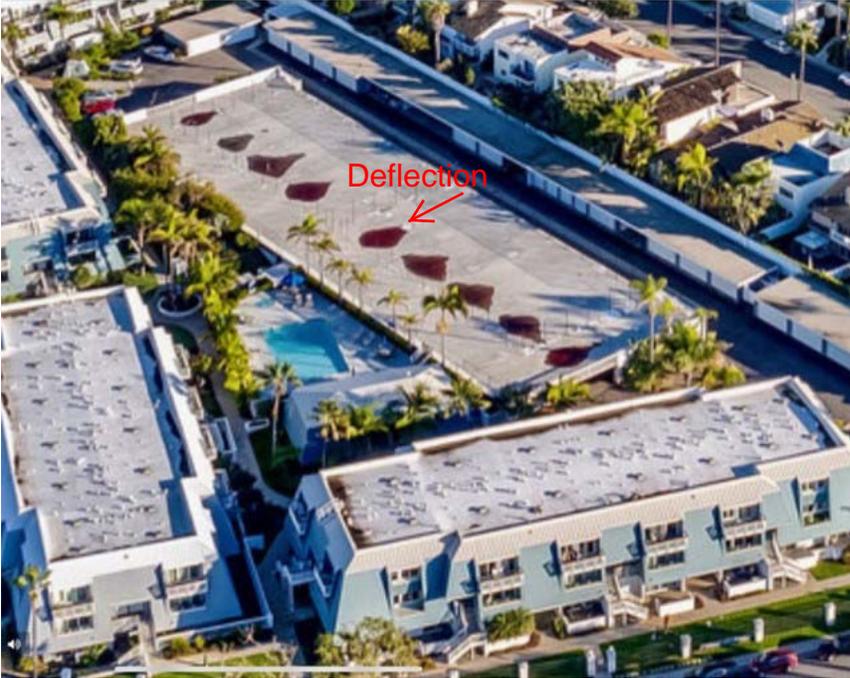
2022 0124 Photo 004 Overhead View of Deflection

The attached photos were taken on January 24, 2022 along with a drone photo taken last weekend, Photo 004. The drone photo shows the deflection (sagging) between the exiting support column rows as nine puddles of water.

Photo 004: Overhead View of Parking Structure Ponding due to Deflection (Sagging) Between Rows of Support Columns

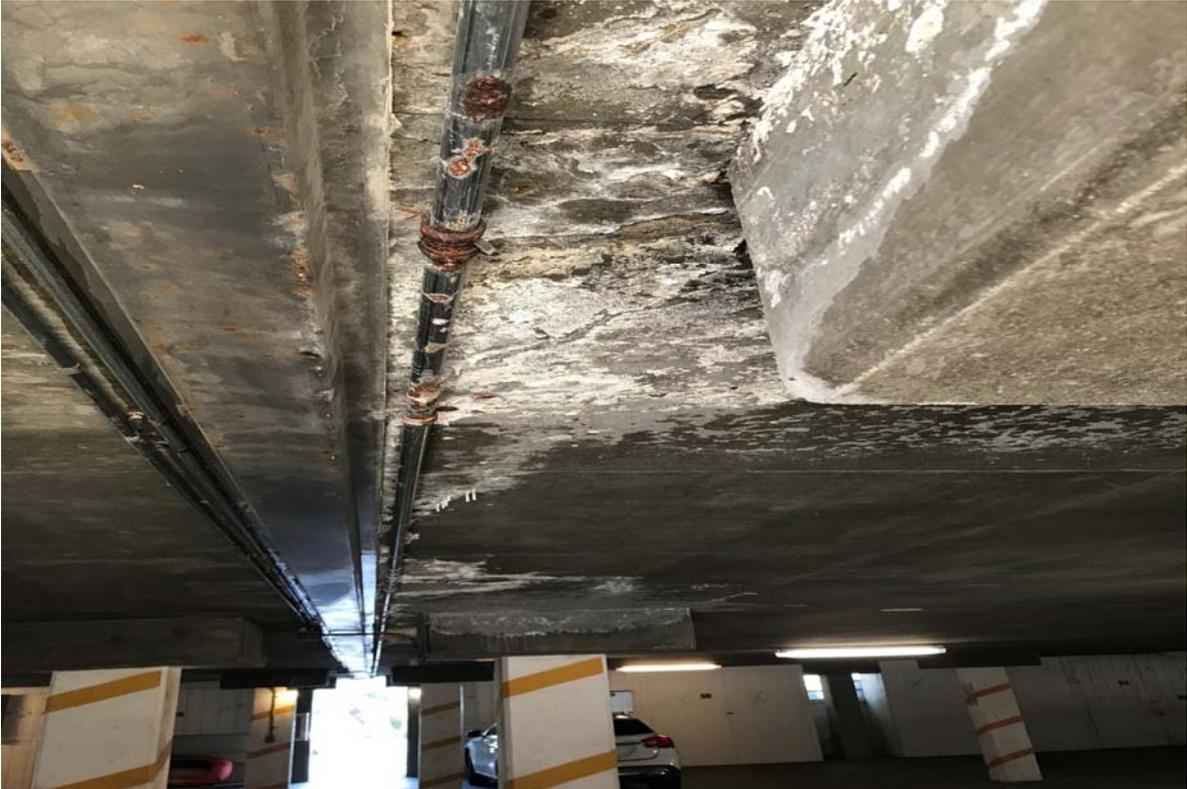
2022 0124 Photo 005 Garage Overhead Centerline

Photo 005: Garage Overhead Centerline (Efflorescence and moisture coming out of the slab)

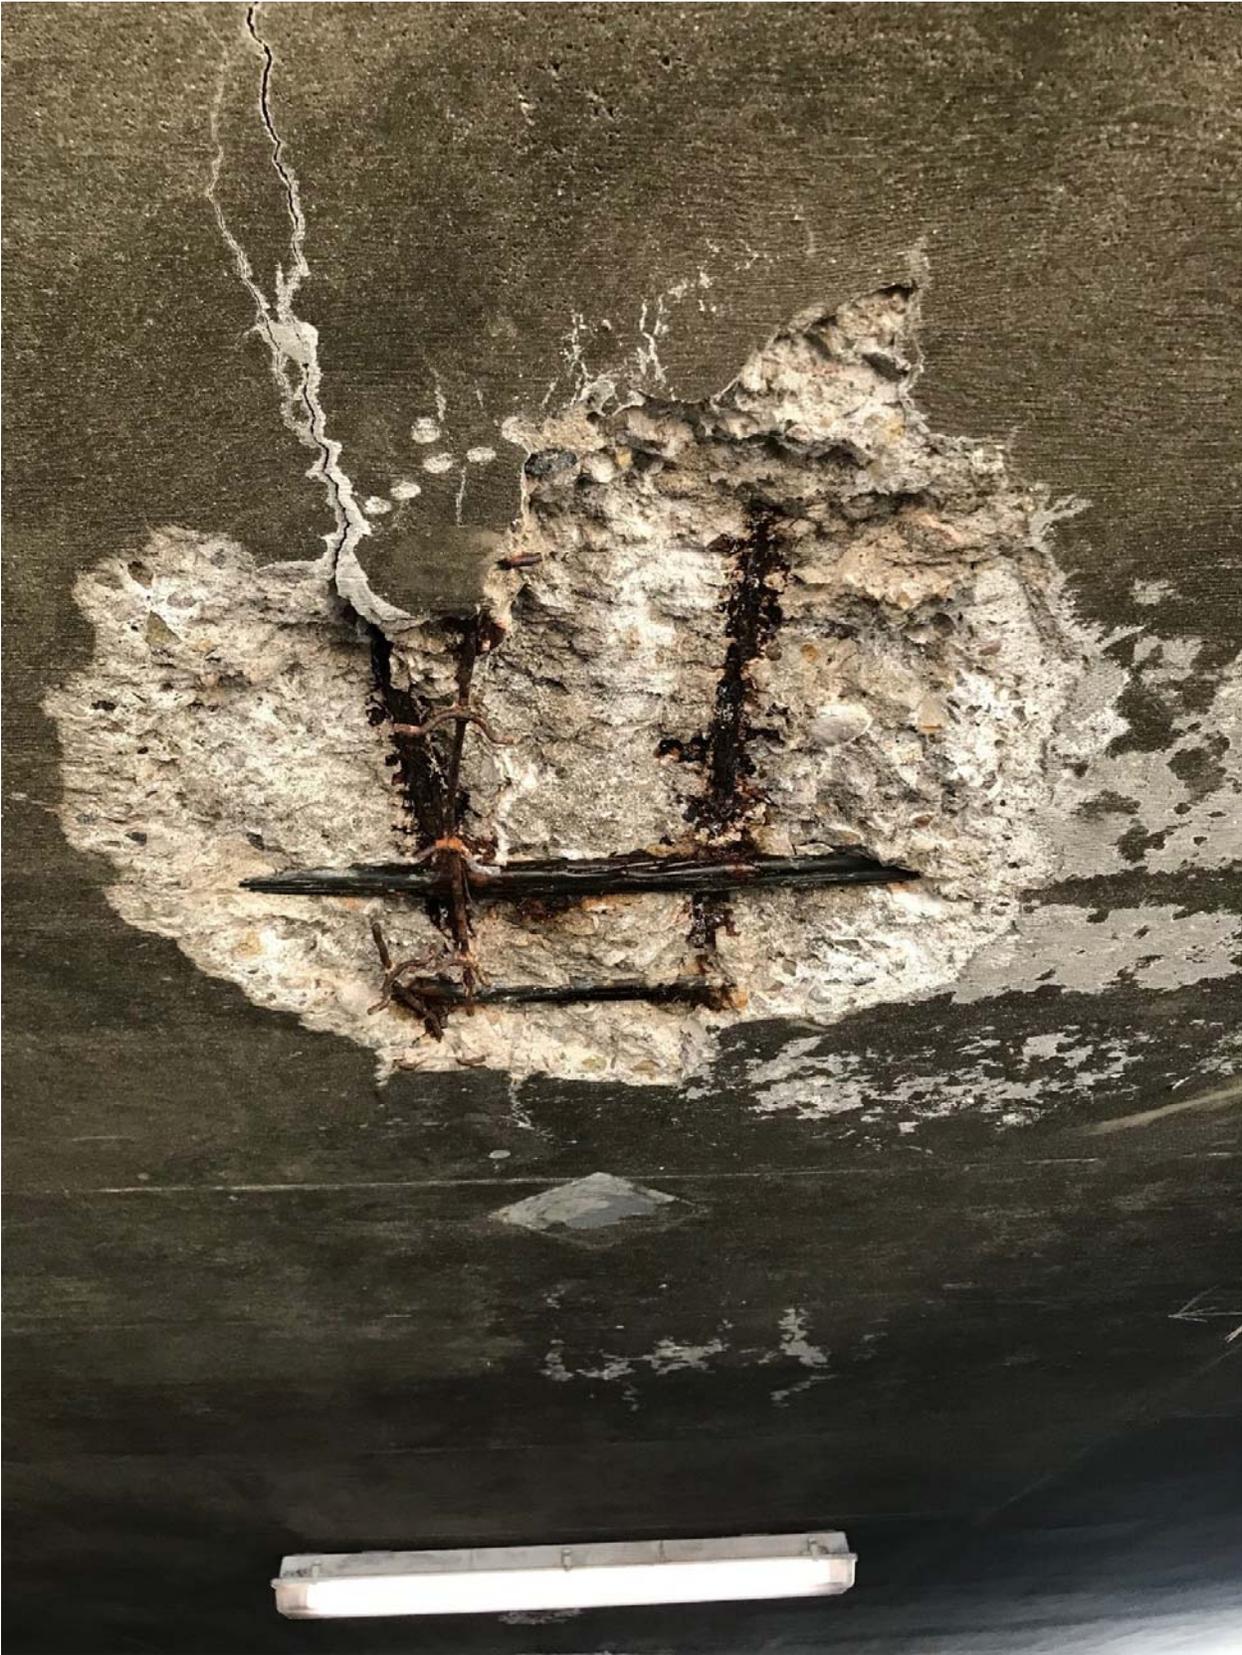
2022 0124 Photo 006 Garage Overhead SE Corner

Photo 006: Garage Overhead Southeast Corner – (spalling concrete, corroded rebar and, damaged cables)
